### **Incident of Interest**

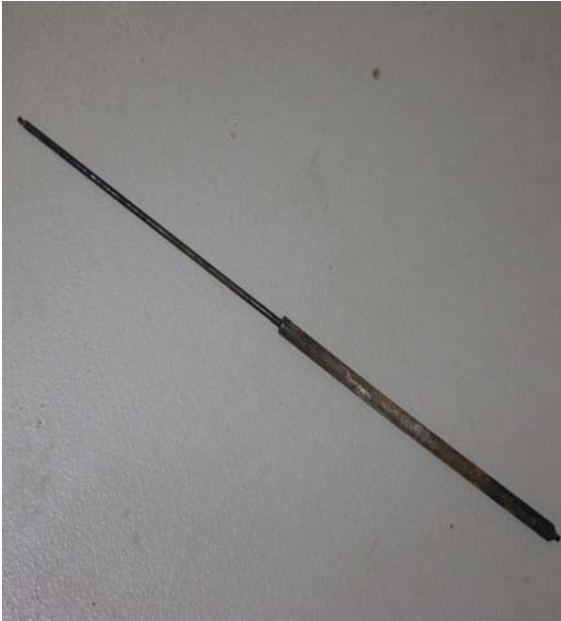
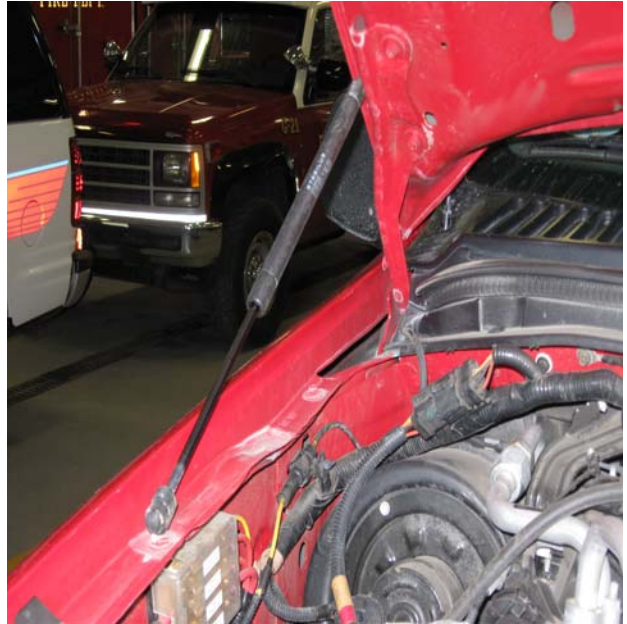
On January 12, 2009 at 7:11 a.m., the Plymouth Fire Department responded to a reported car fire on Carlson Parkway over I-494. Units arrived to find a four door sedan with the engine compartment fully engulfed. Engine 21 laid the front bumper line and began a fire attack from the front corner of the vehicle. After the bulk of the fire was knocked down, the crew began to open the hood to check for further involvement. As the hood was being opened, the gas-operated strut that holds the hood up in the open position was found about 15' in front of the vehicle fully extended as shown in the picture above. The strut which contains compressed gas had blown away from the vehicle. There are two documented cases in other parts of the country of firefighters being badly injured from these types of struts. In one case, the strut went through a firefighter's gloved hand and in another the strut went through the firefighter's leg. A few safety tips to remember:

- Struts are located both under the hood and in the rear hatch.
- Approach the vehicle from the corners, not the front or the rear.
- Wear full PPE at all times.
- Put water on the fire from a safe distance to cool the area where the struts may be located.
- Gas loaded bumpers can cause the same reaction injuring firefighters.
